Marine Corrosion Studies

The Effects of Dissimilar Metal Couples and Toxicants from Antifouling Paints on the Corrosion of 5086 and 6061 Aluminum Alloys and Their Response to Cathodic Protection

(Fourteenth Interim Report of Progress)

T. J. LENNOX, JR., M. H. PETERSON, J. A. SMITH,
AND R. E. GROOVER

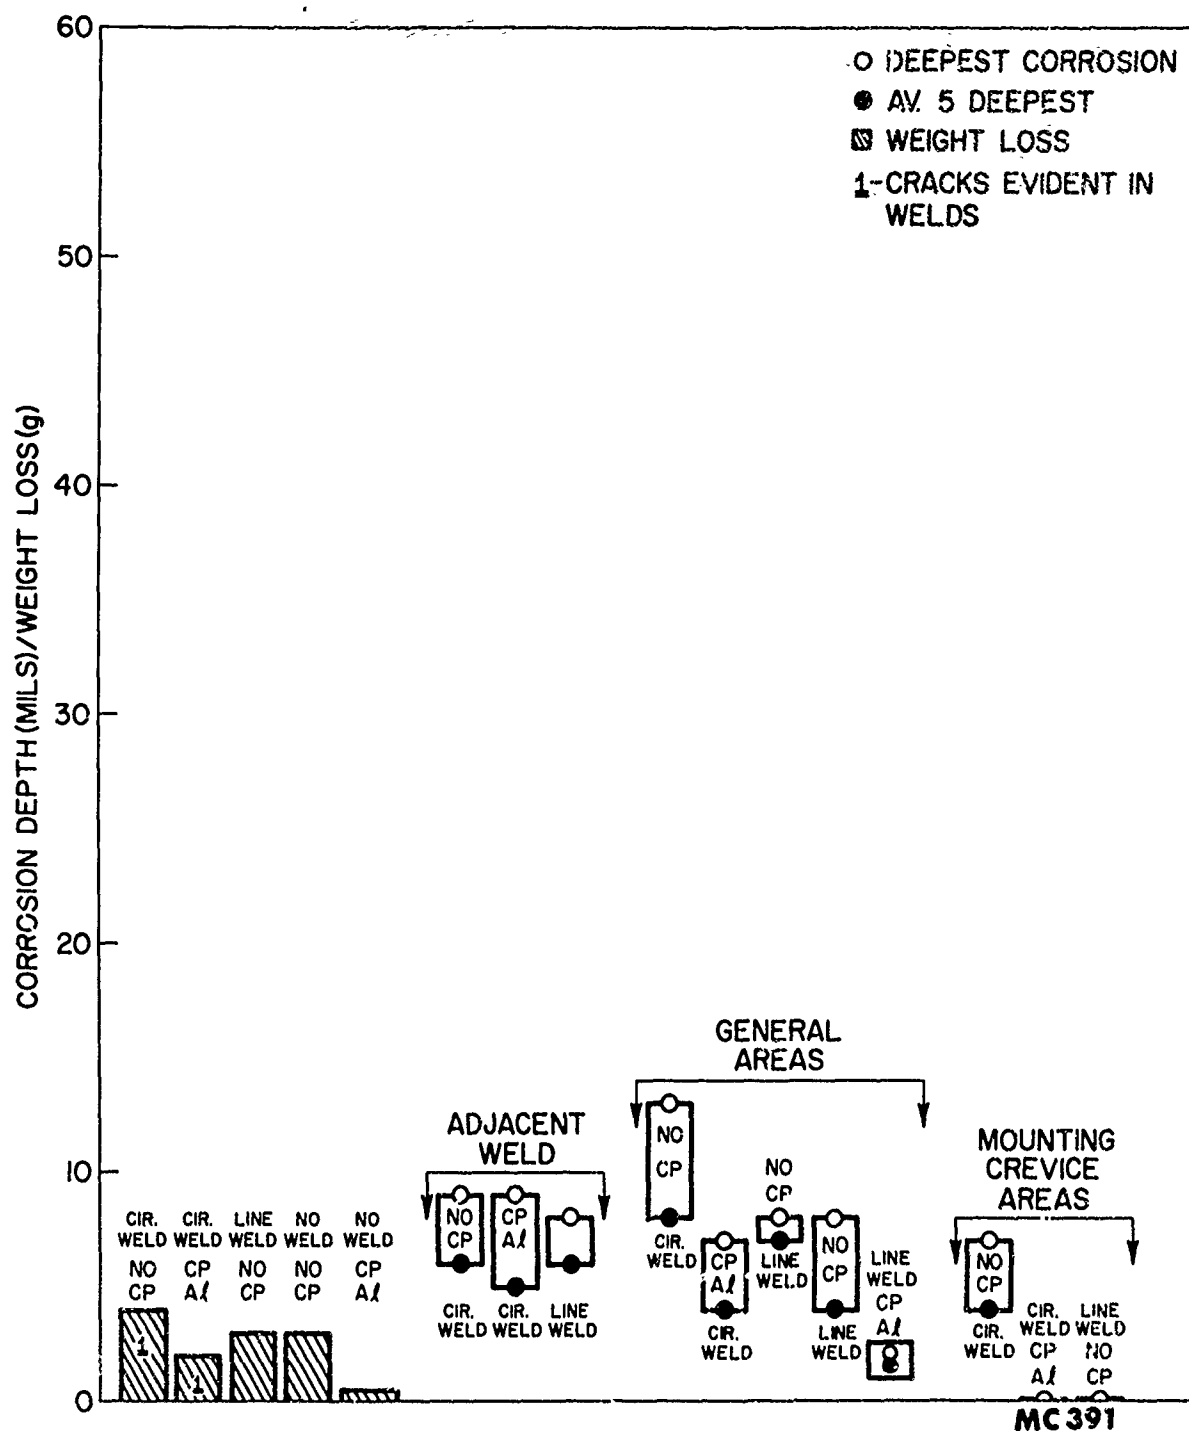
The depth of corrosion and the response to cathodic protection for various areas on the welded specimens of 5086-H32 aluminum are shown in Fig. 2. These data showed that the deepest corrosion on any of the welded specimens in seawater was 13 mils and that cathodic protection effectively reduced the depth of corrosion except at the area immediately adjacent to the weld on the circular welded specimen. There was evidence of cracks in the welds, notably on the circular welded specimen. The weld cracks were evident after exposure whether or not the specimen was cathodically protected by an aluminum anode, but it was not certain whether these cracks were present prior to the exposure. The weld area and areas adjacent to the weld on

Fig. 2 - Welded 5086-H32 aluminum; with and without cathodic protection (CP), 809 days in seawater at Key West, Florida.

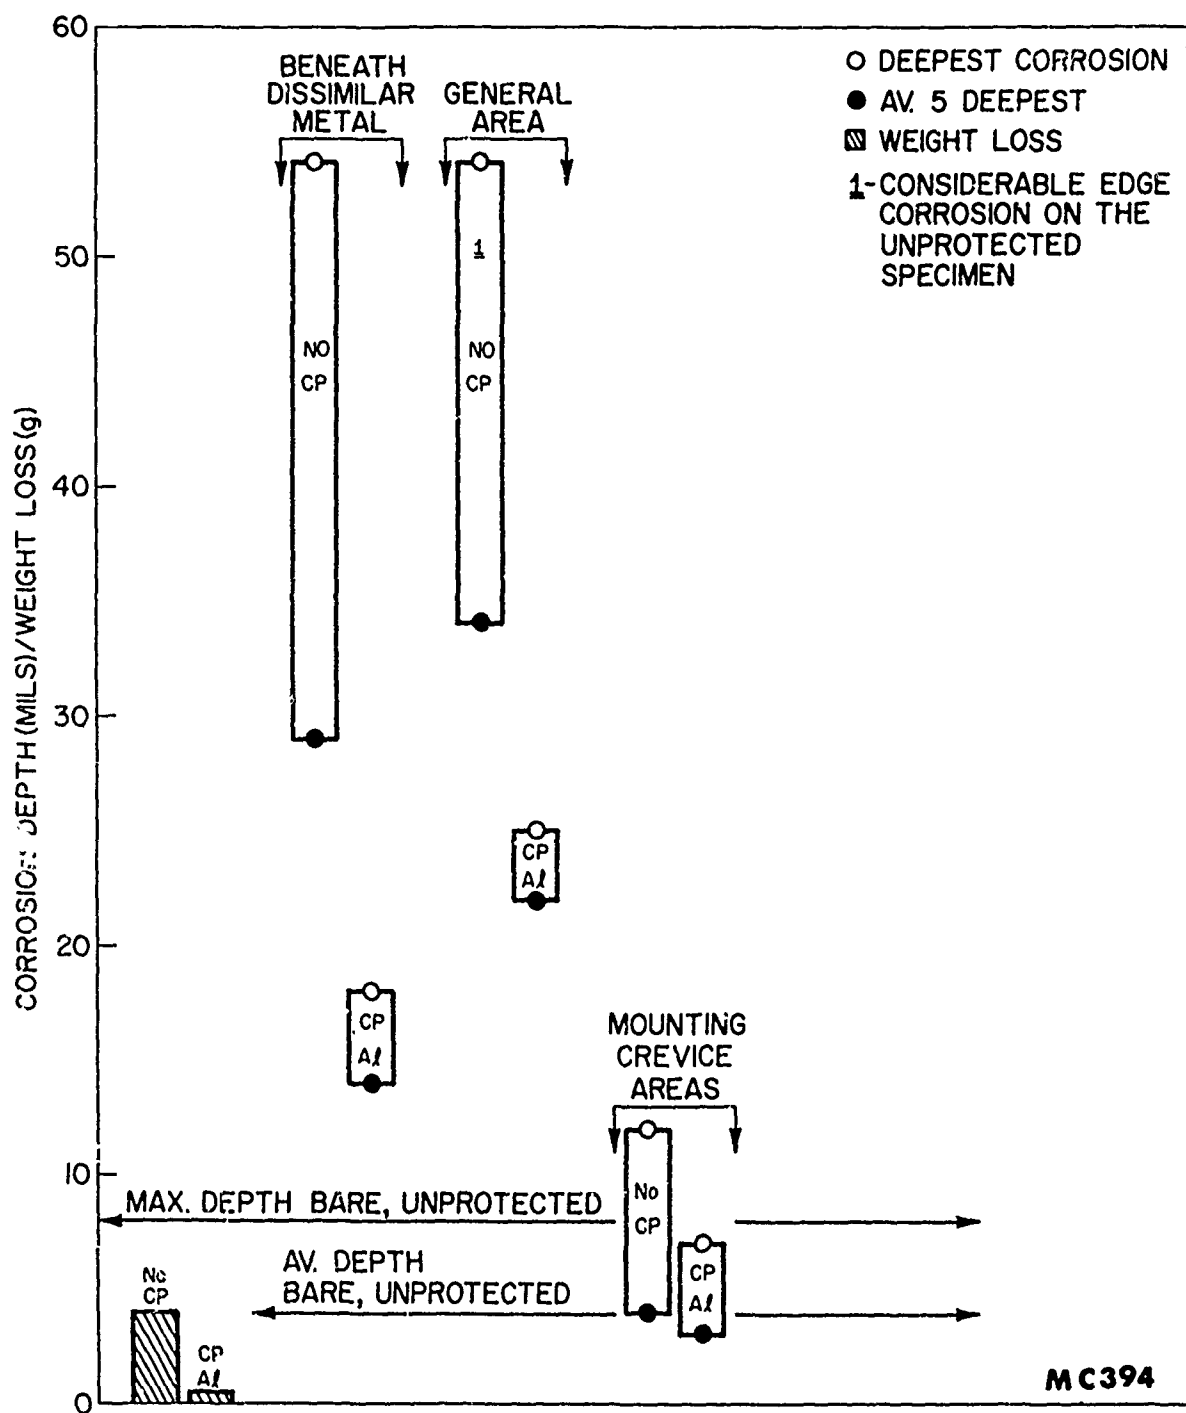
Each of the following dissimilar metals: copper nickel, 10%; yellow brass; 304 stainless steel; and mild steel caused accelerated corrosion at some location on the 5086-H32 aluminum. Of all the dissimilar metals studied the copper nickel caused the deepest corrosion beneath the dissimilar metal and on the general areas of the specimen. The 304 stainless steel accelerated the corrosion of the aluminum the most at the crevice formed by the phenolic mounting spacers. Edge corrosion of the aluminum was also caused by each of the dissimilar metals.

Fig. 5 - 5086-H32 aluminum coupled to copper nickel, 10%; with and without cathodic protection (CP), 809 days in seawater at Key West, Florida.

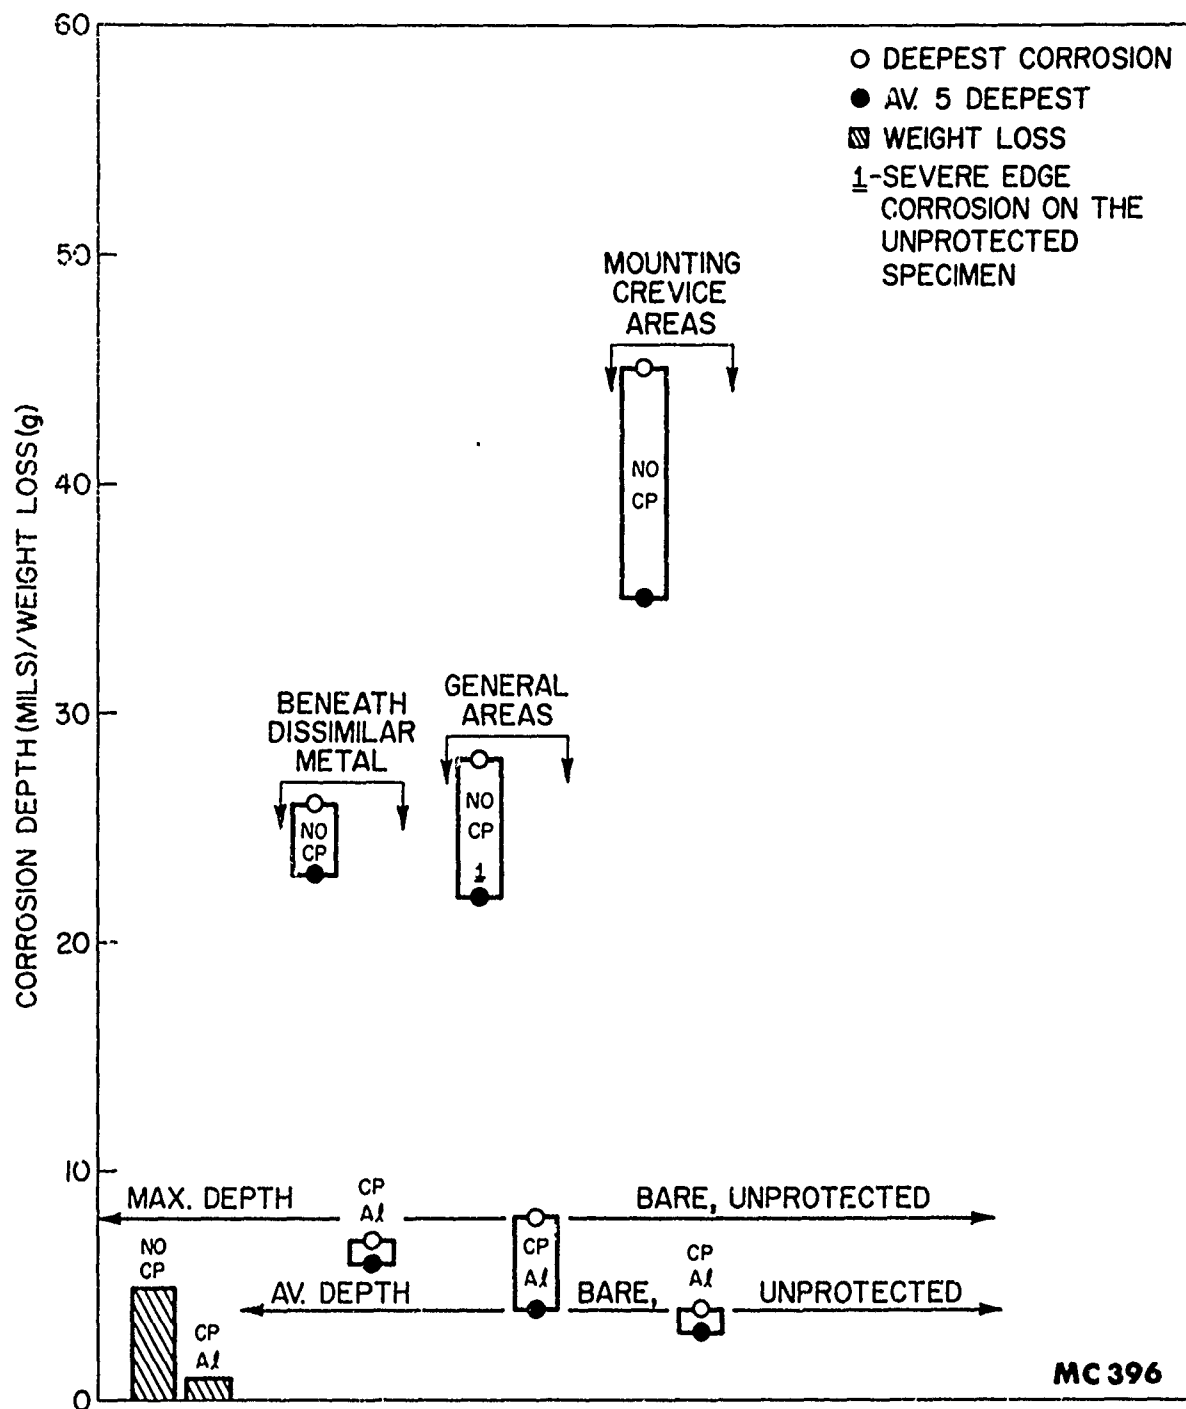
Cathodic protection from the aluminum anodes reduced the depth of corrosion on the 5086-H32 aluminum caused by the dissimilar metals, but only in the case of the 304 stainless steel couple (Fig. 7) was the depth of corrosion reduced to that observed on the bare, uncoupled and unprotected 5086-H32 aluminum. The depth of corrosion on bare 5086-H32 aluminum (with and without cathodic protection) and not coupled to a dissimilar metal has been shown on Fig. 9. The data for the maximum corrosion depth for bare and unprotected 5086-H32 aluminum have been shown on the appropriate graphs for comparative purposes.

Fig. 7 - 5086-H32 aluminum coupled to 304 stainless steel; with and without cathodic protection (CP), 809 days in seawater at Key West, Florida.

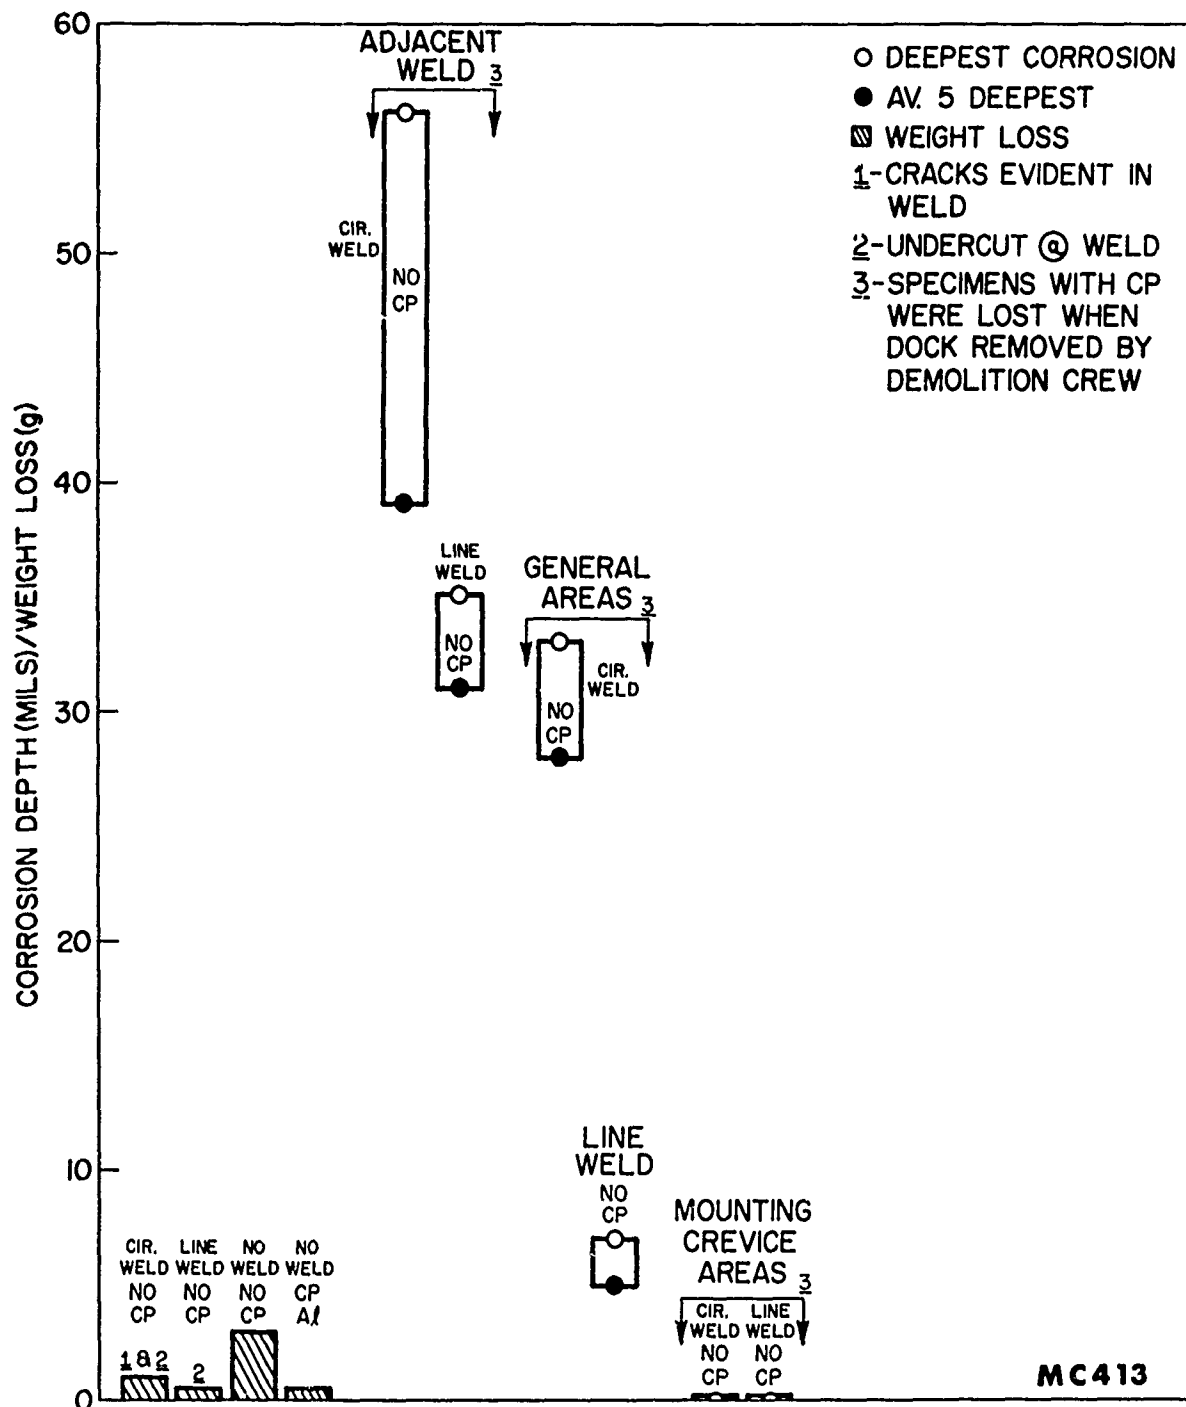
The data for the depth of corrosion on the welded specimens of 5086-H32 aluminum exposed for 675 days in the Potomac River are summarized in Fig. 24. The 5086-H32 aluminum corroded to a depth of 56 mils adjacent to the weld and to 33 mils on general areas of the specimen. The deepest corrosion occurred on the circular welded specimen which also showed slight cracks in the weld, but it was not certain whether these cracks were present prior to exposure. The weld and adjacent areas on this specimen are shown in Fig. 25.

Fig. 24 - Welded 5086-H32 aluminum after 675 days in the Potomac River.

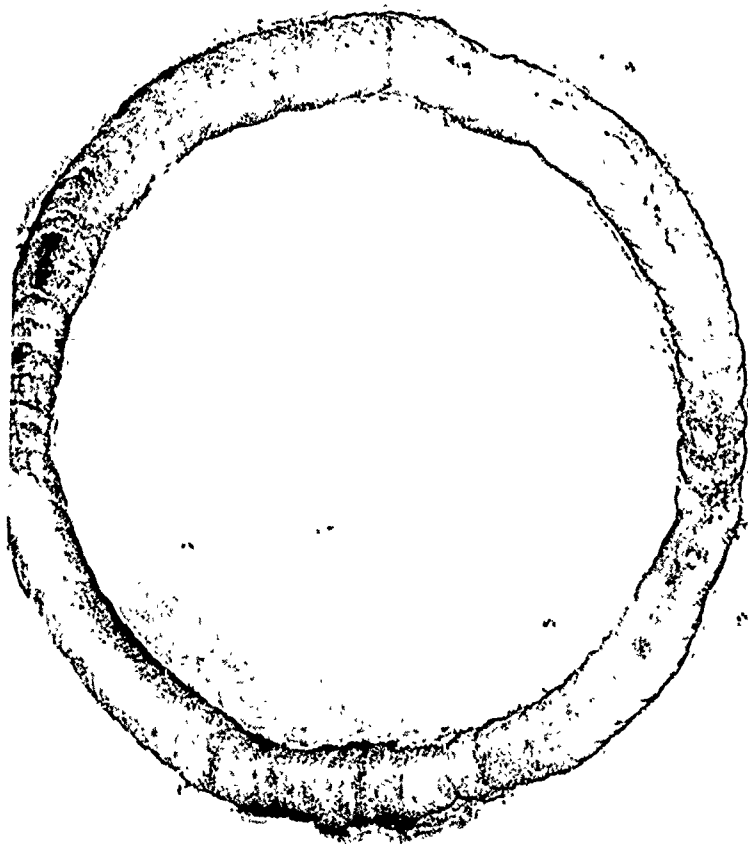
Fig. 25 - Circular weld in 5086-H32 aluminum; without
cathodic protection, 675 days in the Potomac River.
Original magnification 1.25 X

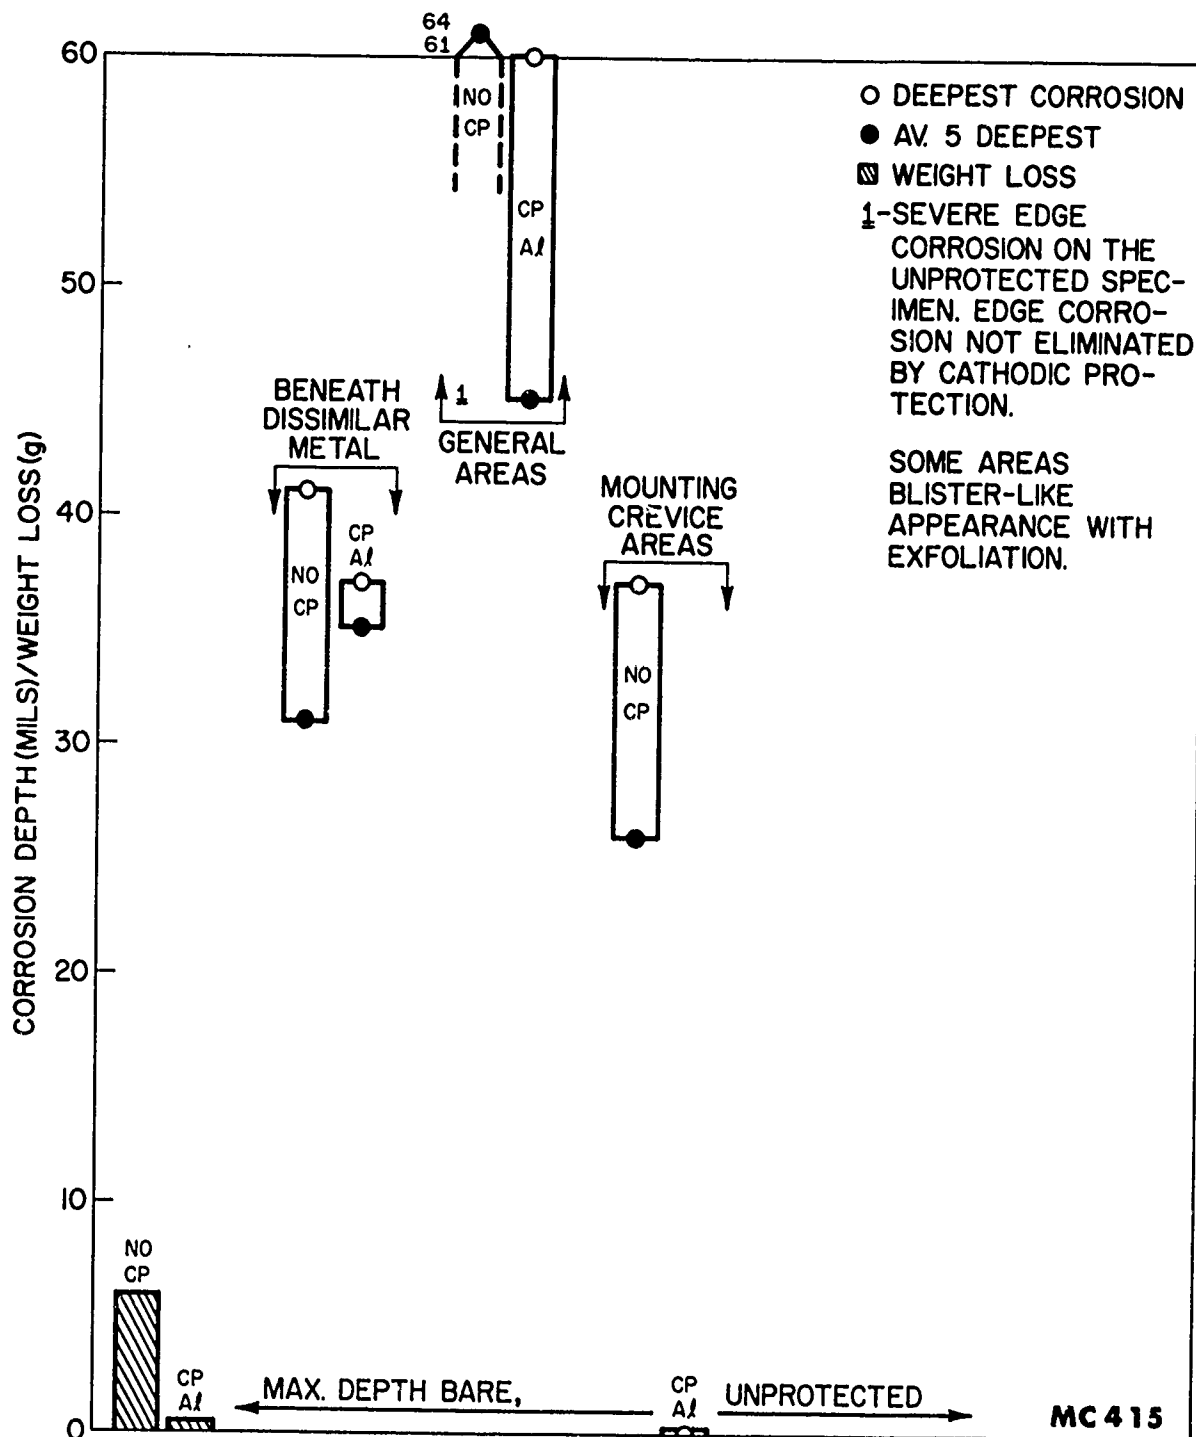
The depth of corrosion produced on the 5086-H32 aluminum by the dissimilar metal couples in the Potomac River and the response to cathodic protection have been shown in Figs. 26 thru 29. Each of the dissimilar metals: copper nickel, 10%; yellow brass; 304 stainless steel; and mild steel caused severe corrosion of the 5086-H32 aluminum. On the general areas of the aluminum the corrosion in the Potomac River was $1\frac{1}{2}$ to 2 times deeper than on similar specimens exposed in seawater at Key West. (Compare Figs. 5,6,7,8 with Figs. 26,27,28, and 29, respectively).

Fig. 26 - 5086-H32 aluminum coupled to copper nickel, 10%; with and without cathodic protection (CP), 675 days in the Potomac River.

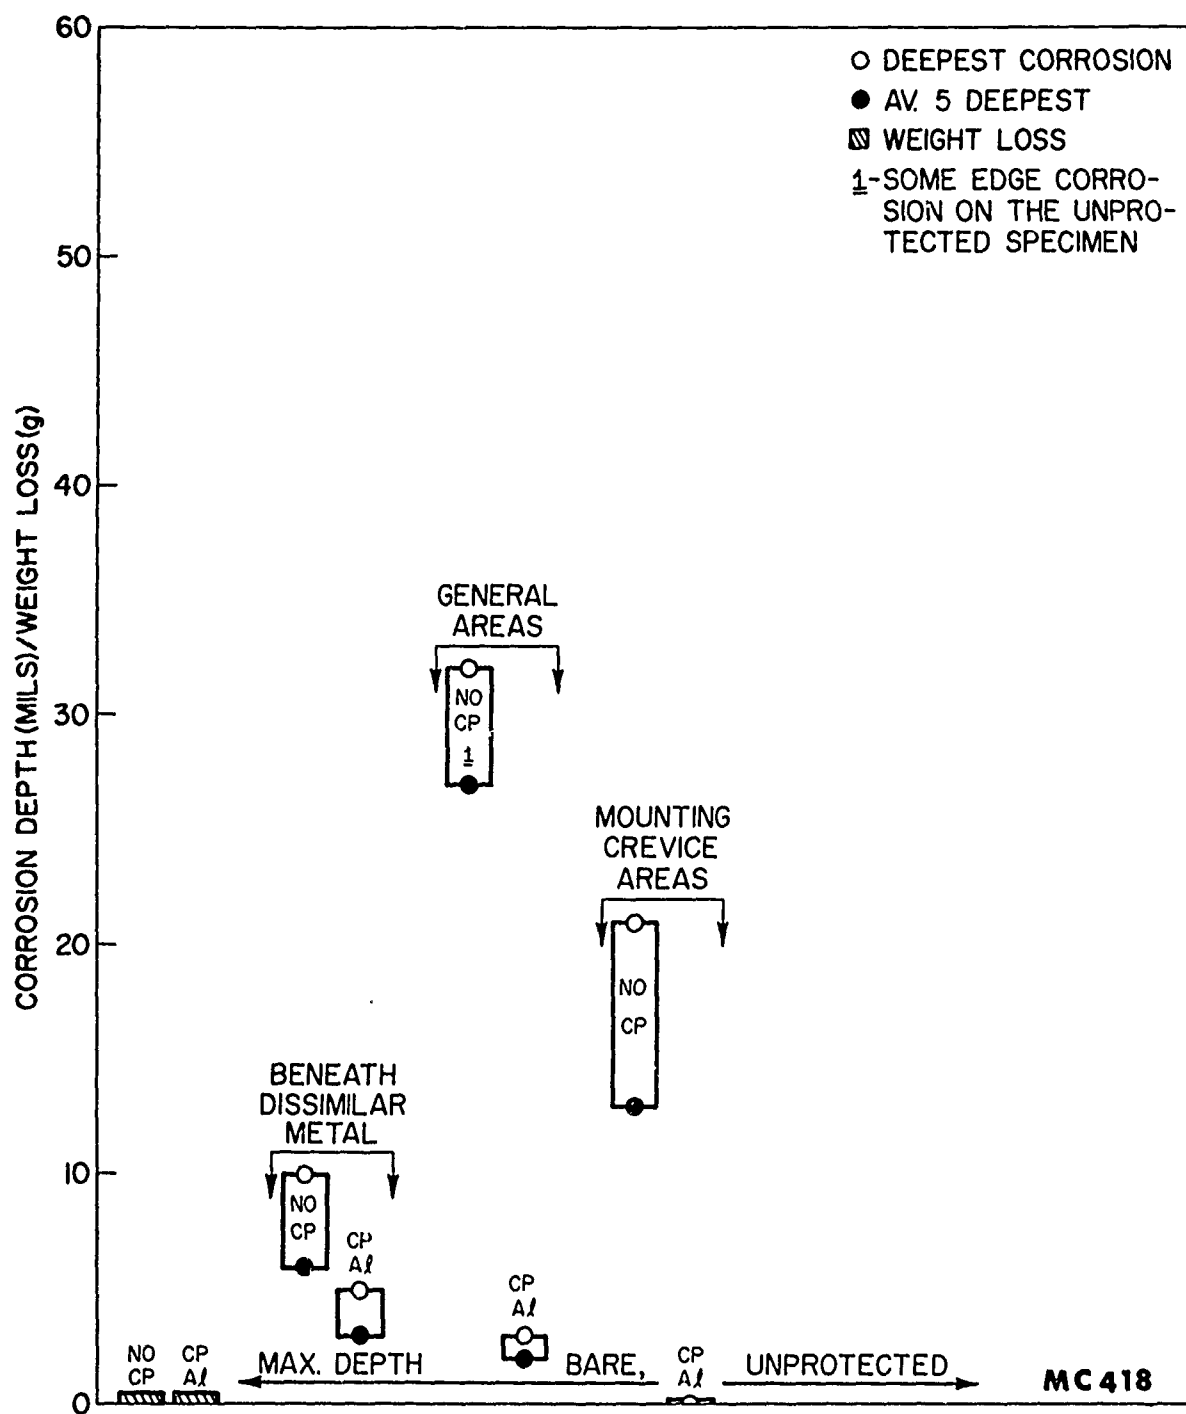
In the case of the mild steel couple in the Potomac River cathodic protection was effective and significantly reduced the depth of corrosion at all locations on the 5086-H32 aluminum, Fig. 29.

Fig. 29 - 5086-H32 aluminum coupled to mild steel; with and without cathodic protection (CP), 675 days in the Potomac River.

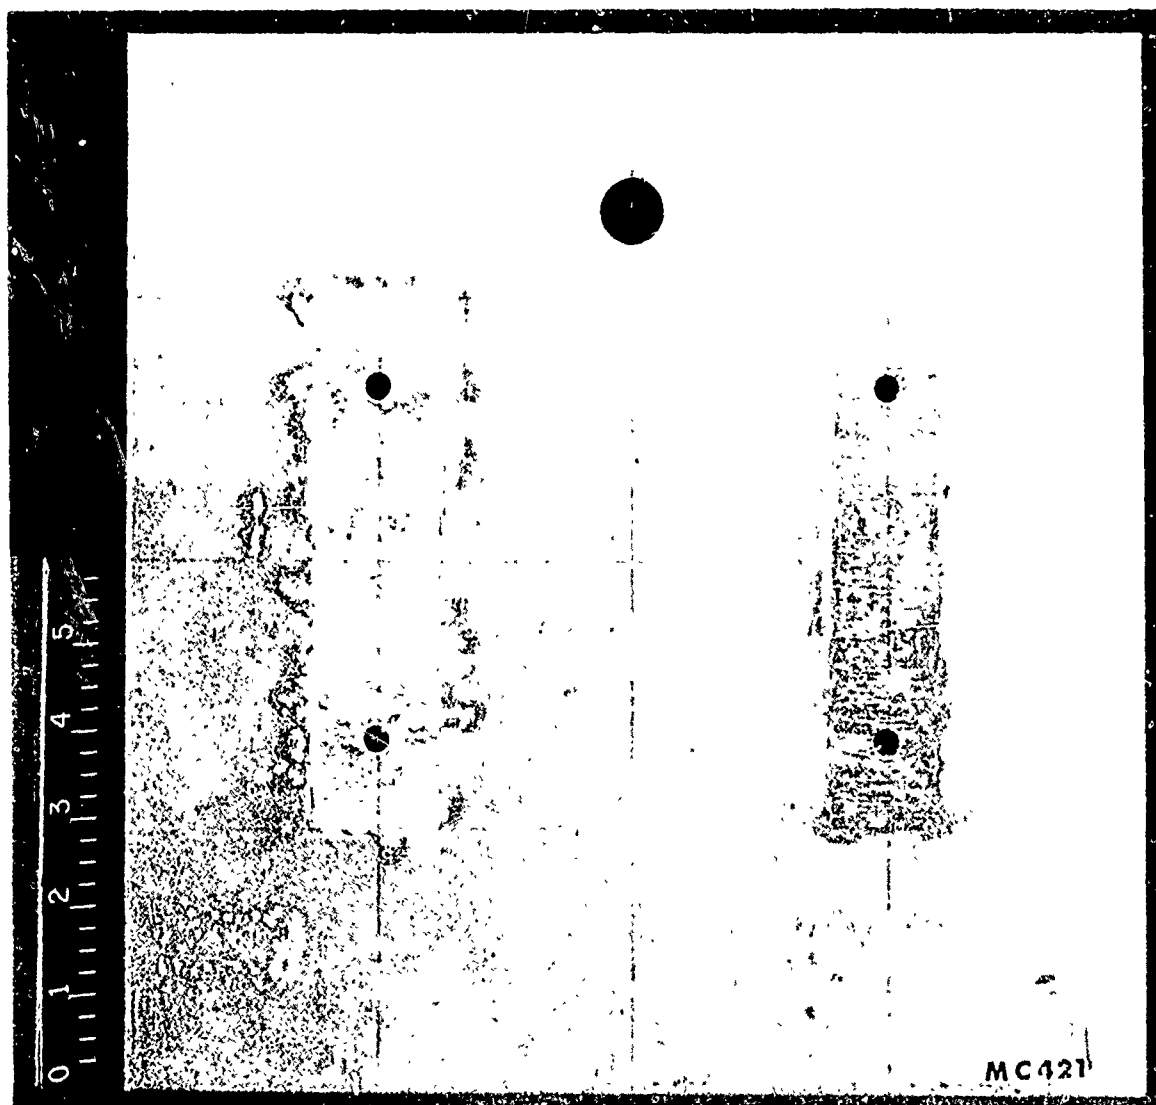
Fig. 32 - 5086-H132 aluminum coupled to copper nickel, 10";
with cathodic protection, 675 days in the Potomac River.
Original magnification 0.5 X

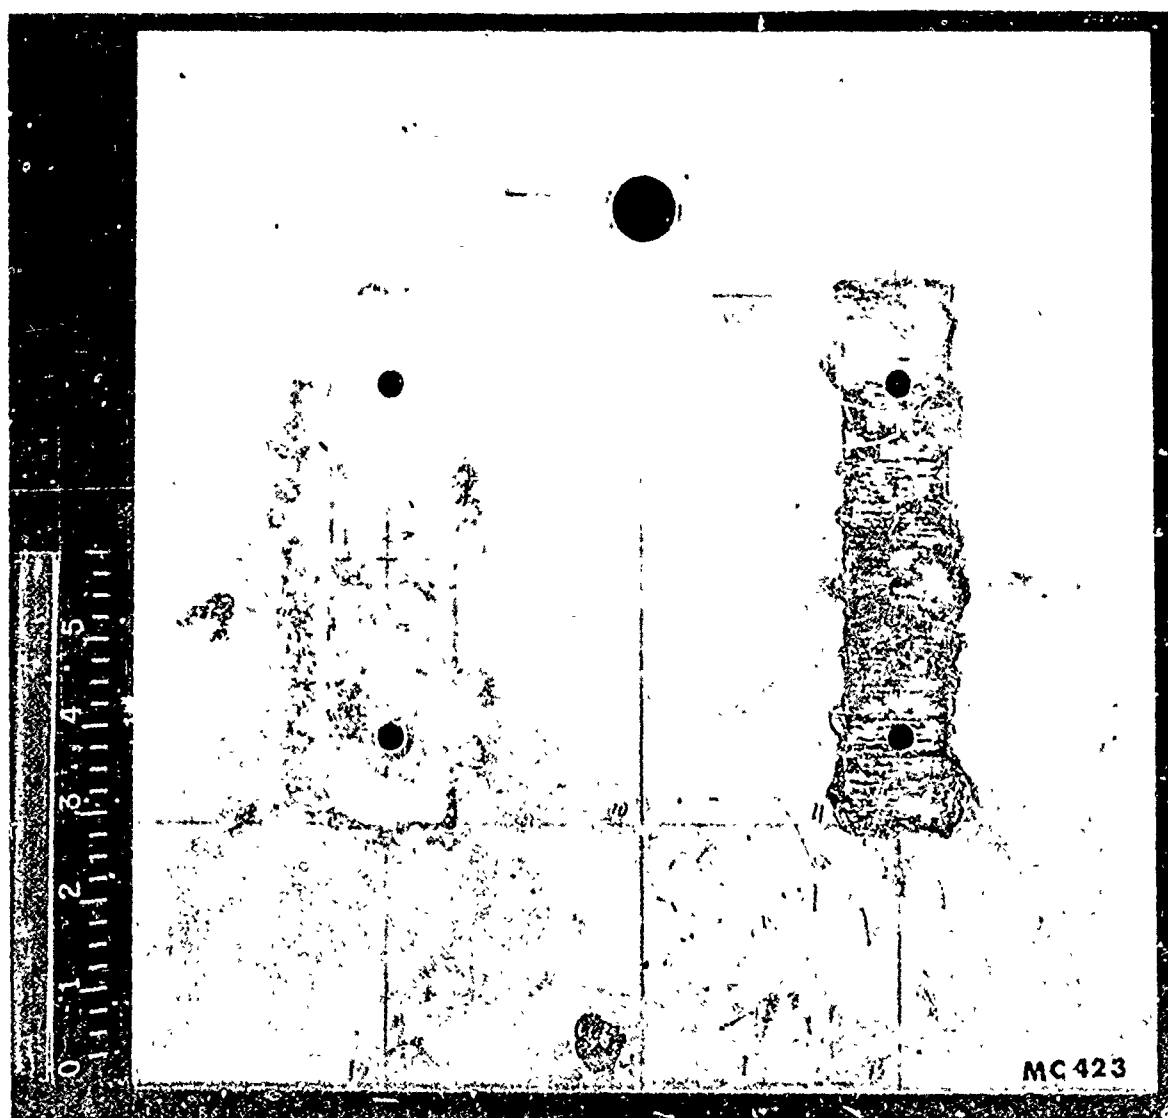
Fig. 34 - 5086-II32 aluminum coupled to yellow brass;
with cathodic protection, 675 days in the Potomac River.
Original magnification 0.5 X
